**Figure 5.19-1 Aggregated TAZs used for Pedestrian/Bicycle Analysis**

**Figure 5.20-1: Soil Cement Wall Augers In Use**

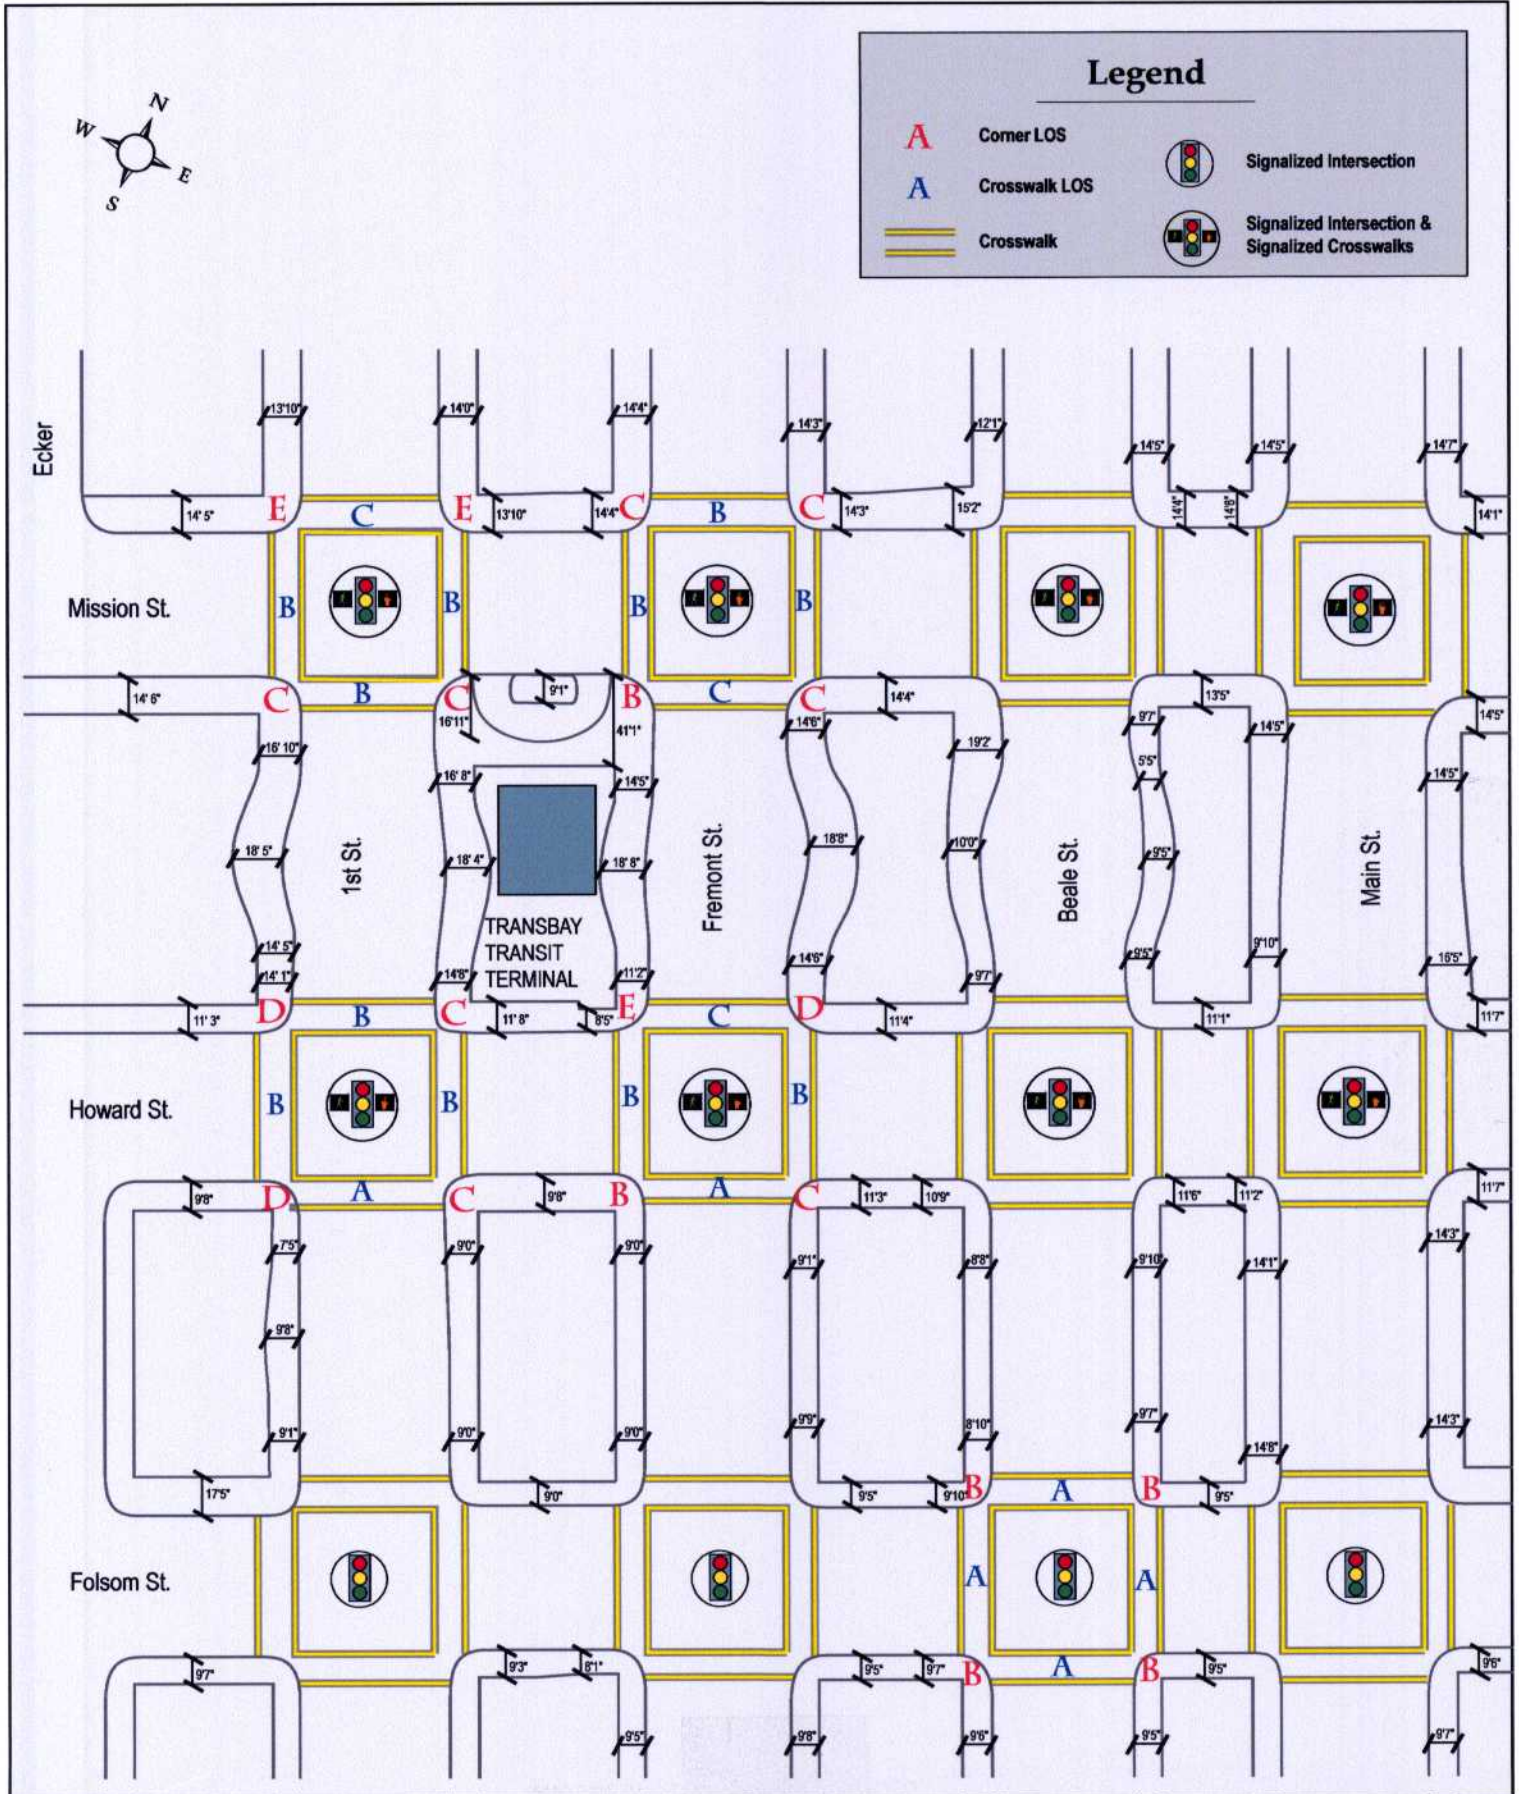
**Figure 5.19-3** Corner & Crosswalk Pedestrian Level of Service (LOS) 2020 Project

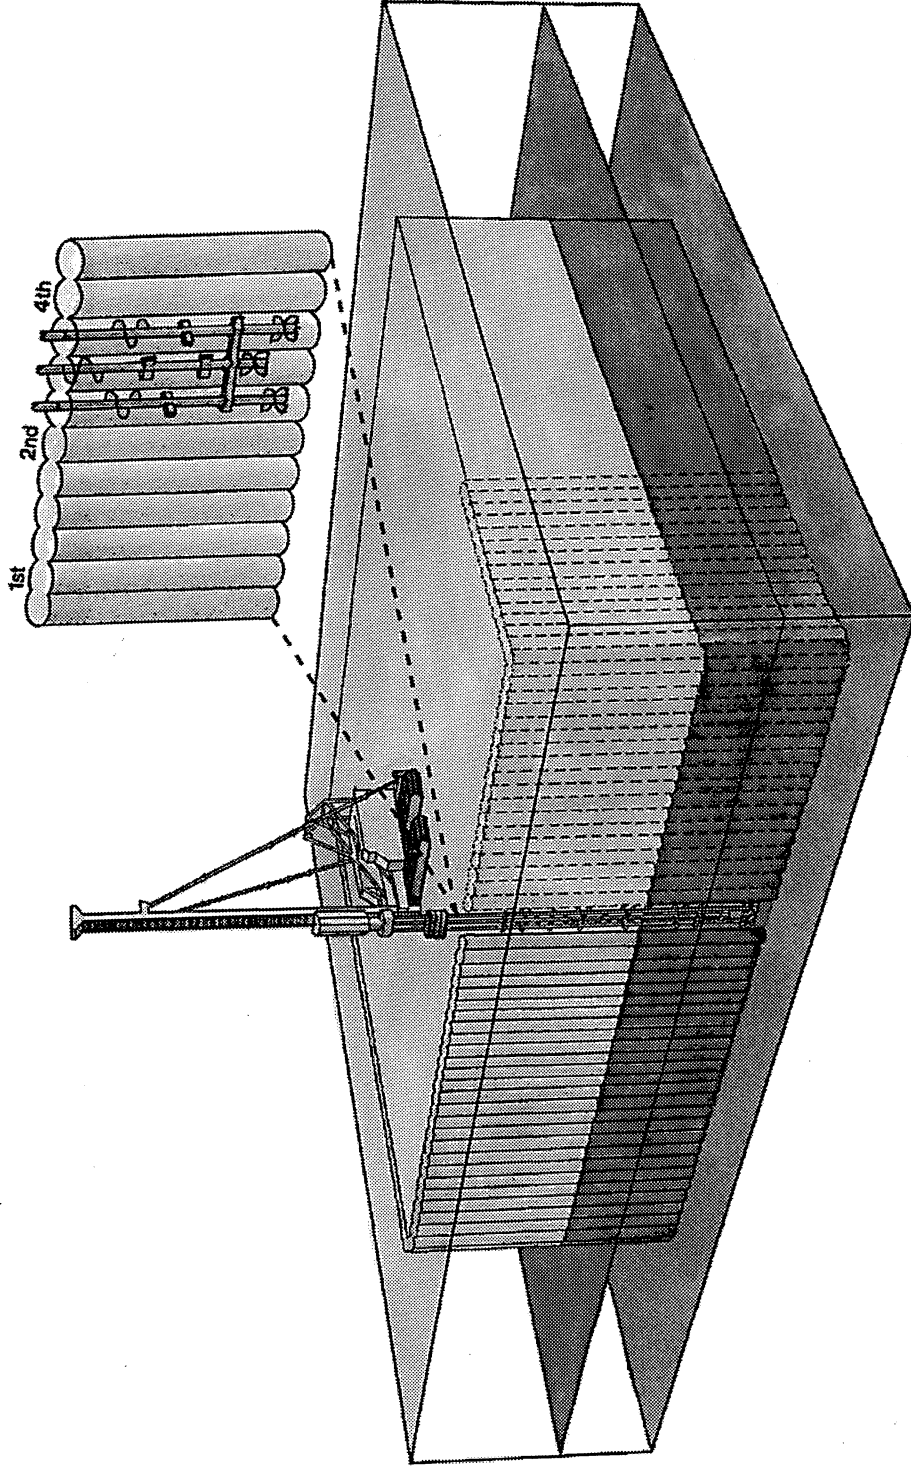
Figure 5.20-2: Column Construction for Soil Cement Walls

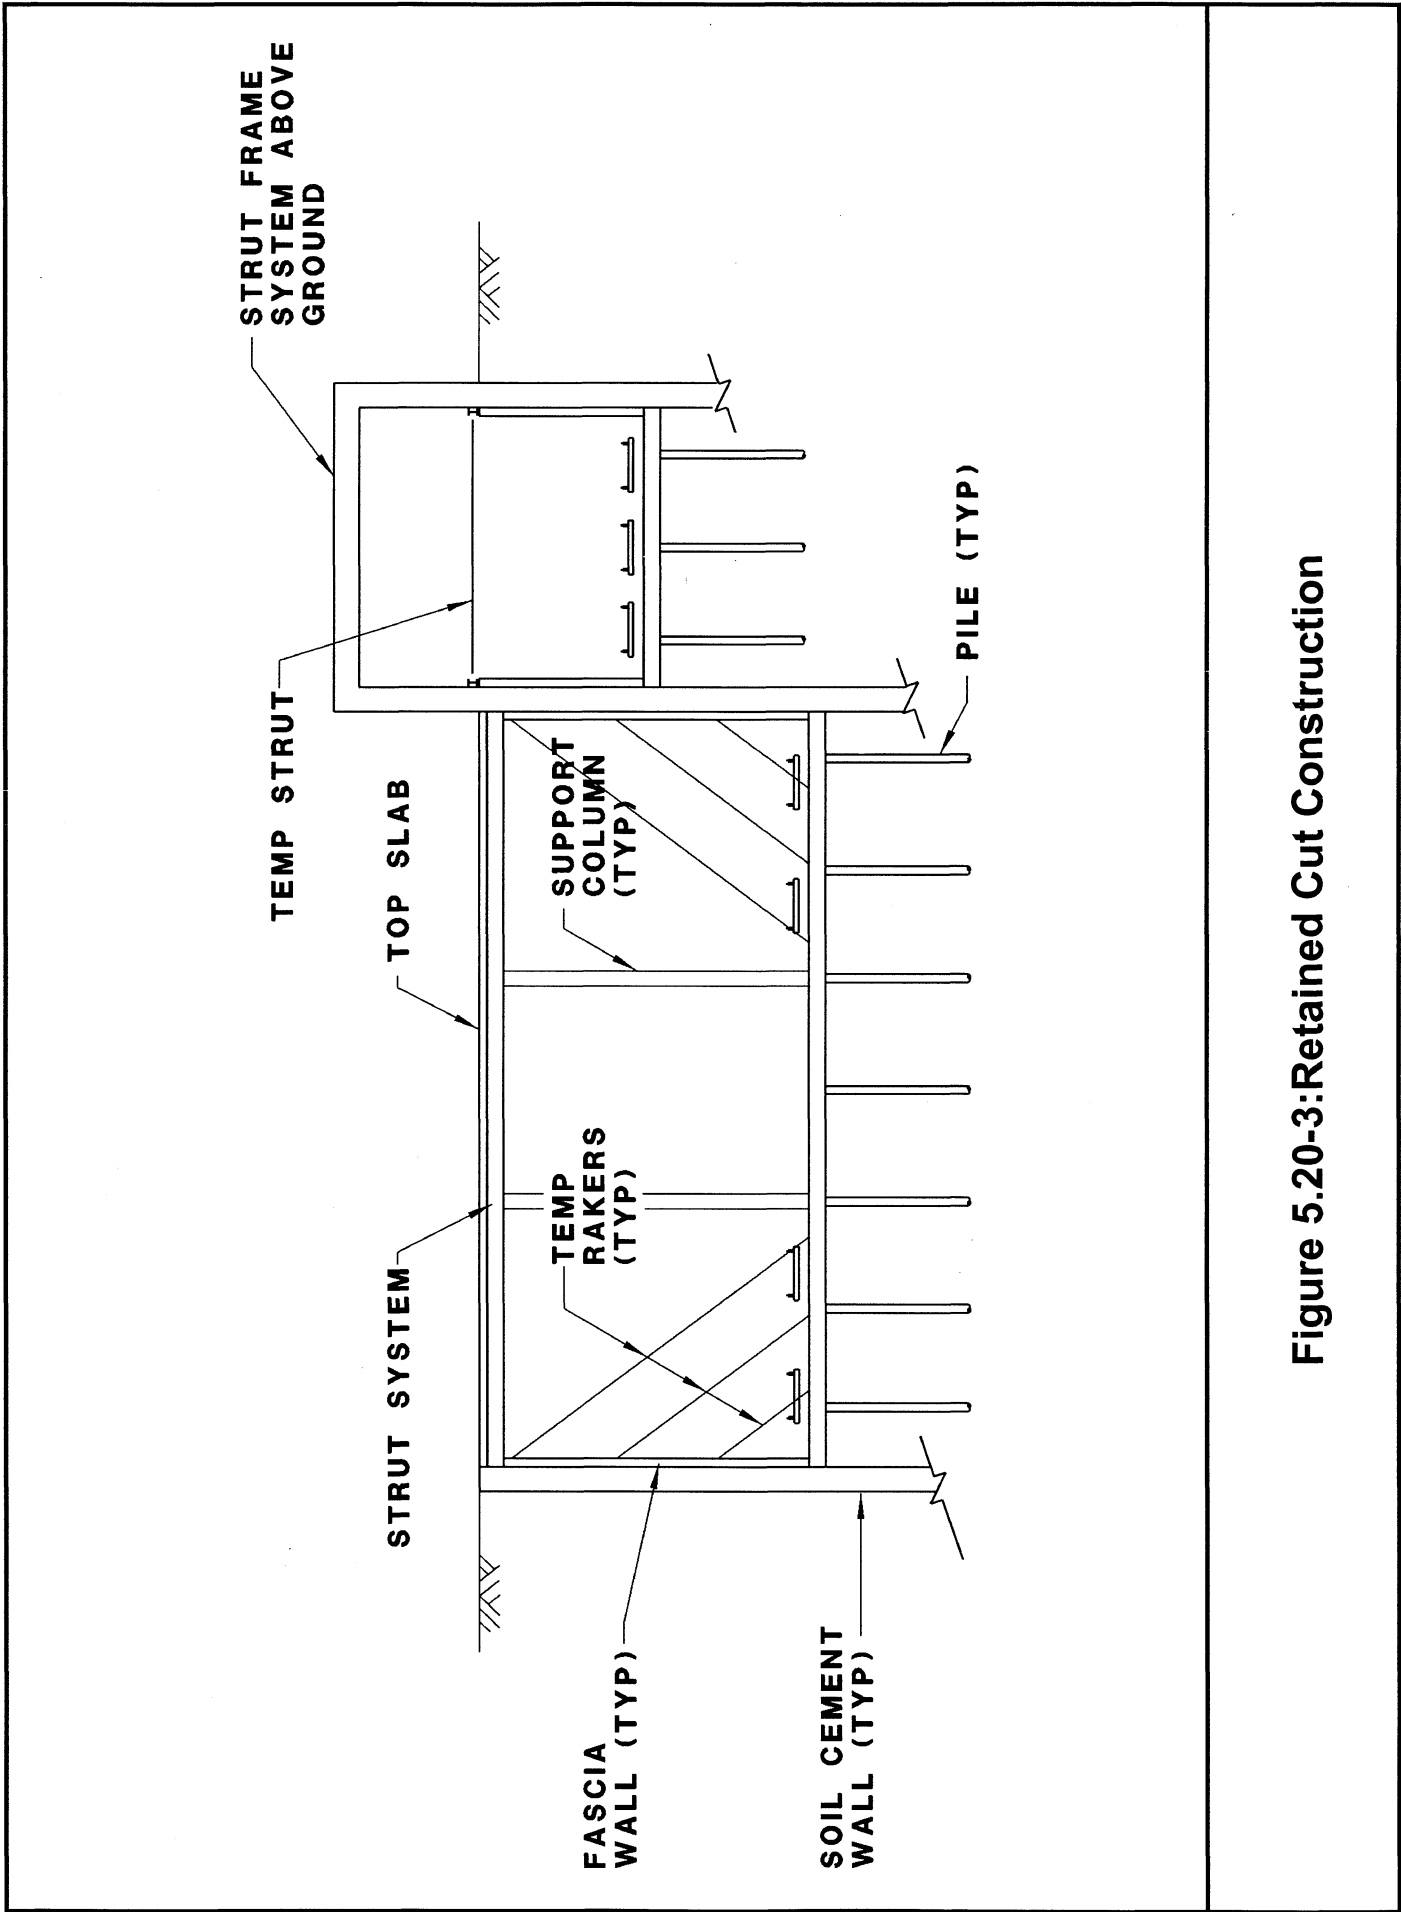
Figure 5.20-3: Retained Cut Construction
